#### **Individual Permit Enhanced Controls Update**

**Grayson Vogel, PE**Project Engineer
N3B/T2S

#### **Enhanced Controls Update**

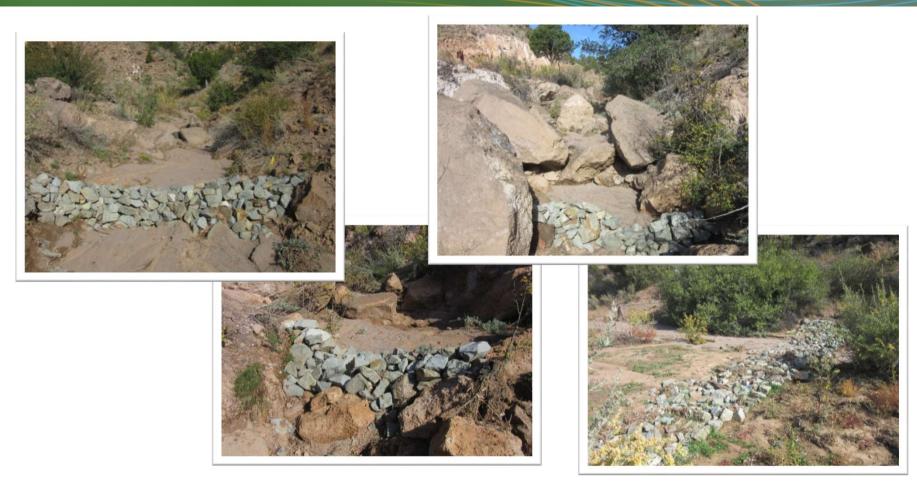
#### **A-SMA-1.1**

Three rock check dams with armored pools and a one rock check dam
