Site Specific Demonstration Screening Process as outlined in the 2022 Storm Water Individual Permit (NM0030759)

November 9, 2022

Active Monitoring SSD: LA- SMA-0.85

Corrective Action Example: M-SMA-12.9

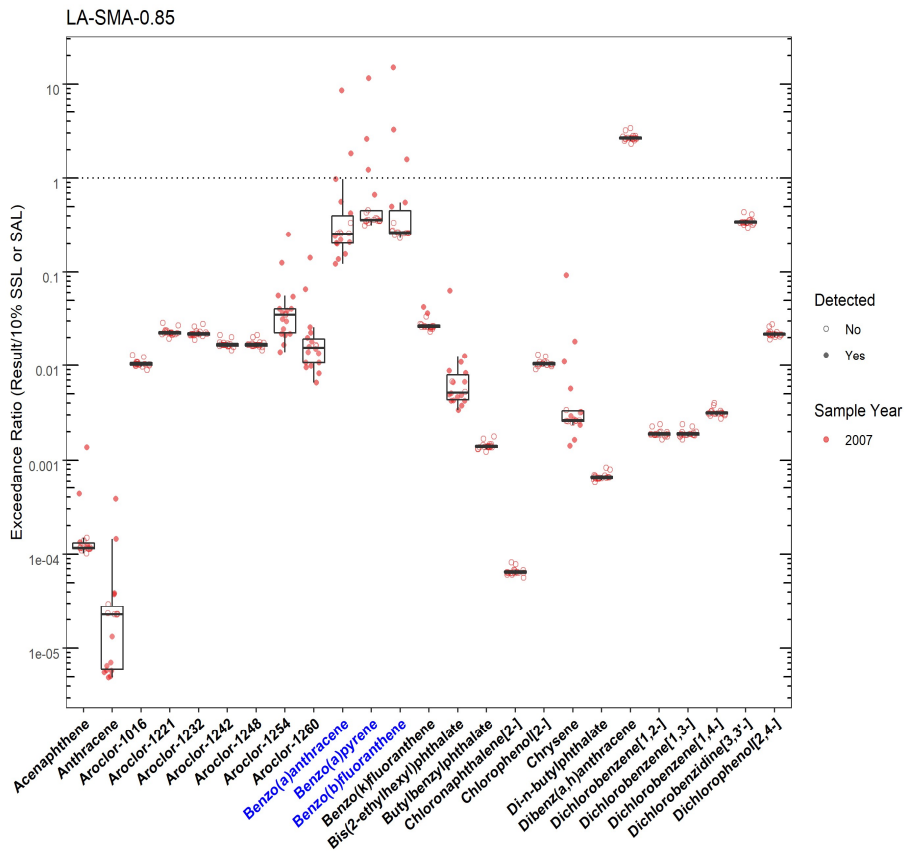
LA-SMA-0.85 Soil Data (pt. 2)

SMA	Parameter Code	Detected	Screening Type	Screening Level (mg/kg)	Max Result (mg/kg)	Date of Max Result
Benzo(a)anthracene	LA-SMA-0.85	56-55-3	Y	SSL_0.1	0.153	1.31	2007-12-05
Benzo(a)pyrene	LA-SMA-0.85	50-32-8	Y	SSL_0.1	0.112	1.30	2007-12-05
Benzo(b)fluoranthene	LA-SMA-0.85	205-99-2	Y	SSL_0.1	0.153	2.29	2007-12-05
Copper	LA-SMA-0.85	Cu	Y	BTV	14.7	15.1	2007-12-05
Cyanide (Total)	LA-SMA-0.85	CN(TOTAL)	Y	BTV	0.500	2.79	2007-12-05
Indeno(1,2,3-cd)pyrene	LA-SMA-0.85	193-39-5	Y	SSL_0.1	0.153	0.606	2007-12-05
Lead	LA-SMA-0.85	Pb	Y	BTV	22.3	70.0	2007-12-05
Zinc	LA-SMA-0.85	Zn	Y	BTV	48.8	276	2007-12-05

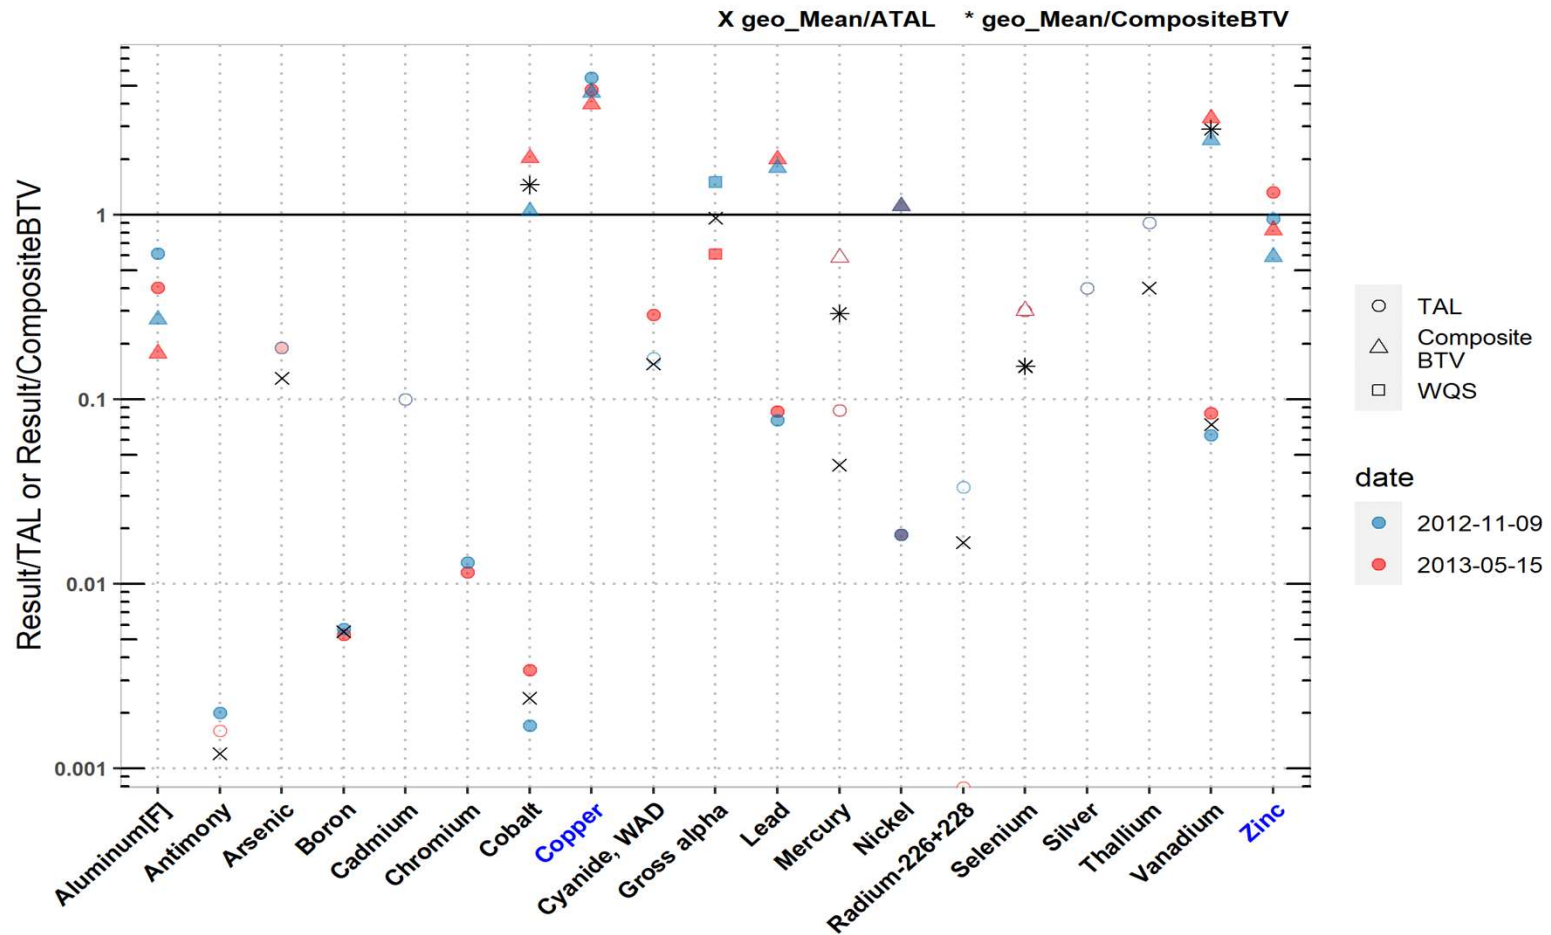
LA-SMA-0.85

SSC data is not available for this location. Solid shapes: Detected Hollow shapes: Non-detected

Copper and Zinc exceeded the TAL and BTV in the storm water samples from 2012 and 2013

- The following Site-related POCs exceeded the applicable screening value in soil data and have not yet been measured in storm water: benzo(a)anthracene, benzo(a)pyrene, benzo(b)fluoranthene, and indeno(1,2,3-cd)pyrene. They will be added for monitoring.
- PCBs were measured in soil data and did not exceed the screening values, but the stream reach is impaired for PCBs and they are Site-related so they will be added for monitoring.
- Copper, lead and zinc also exceeded in soil data but they were previously monitored and will not be added for additional monitoring.

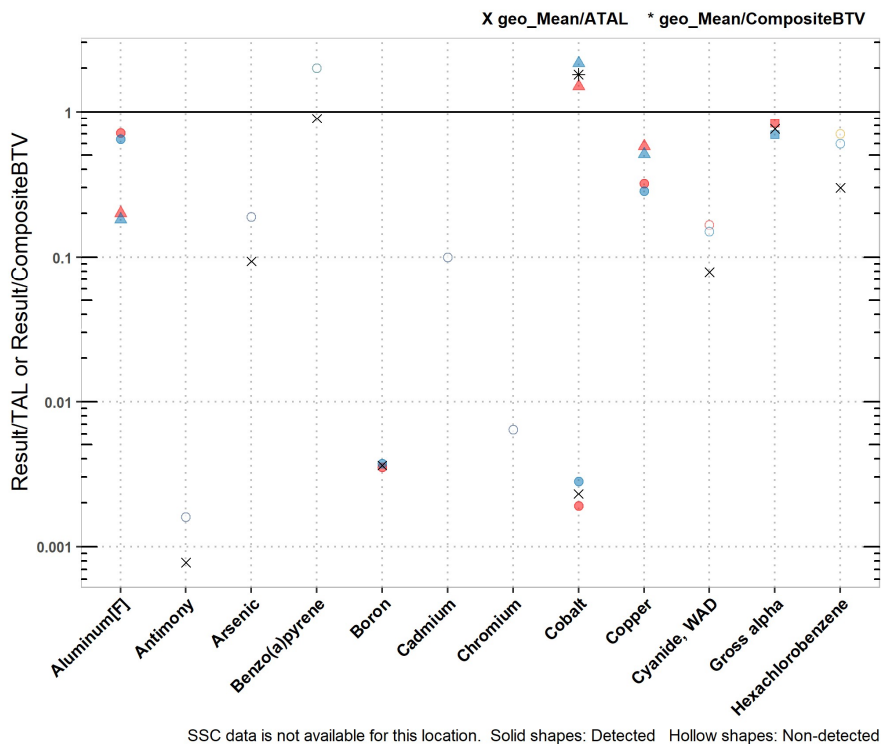
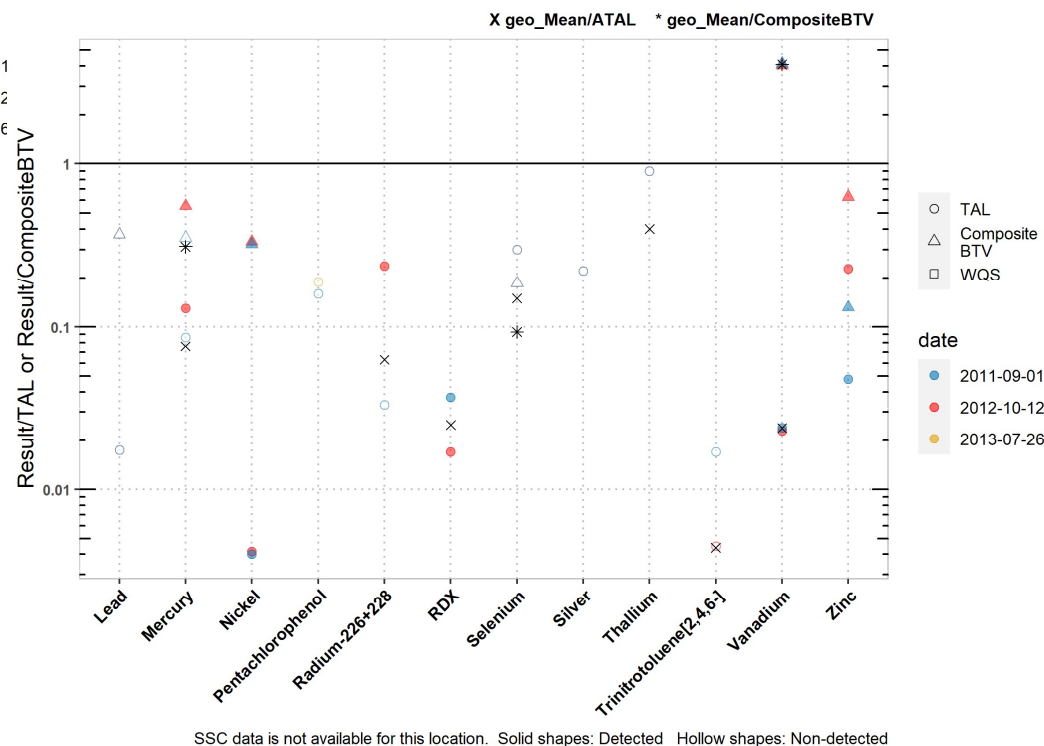
CDV-SMA-2.5

No TAL Exceedances

- All Site-related POCs that exceeded the applicable screening values in soil data were previously monitored in stormwater data and did not exceed TALs.
- No TAL exceedances in confirmation monitoring data.
- Soil sampling for the Sites within the SMA is not complete, the Site will be re-screened when soil data is available.

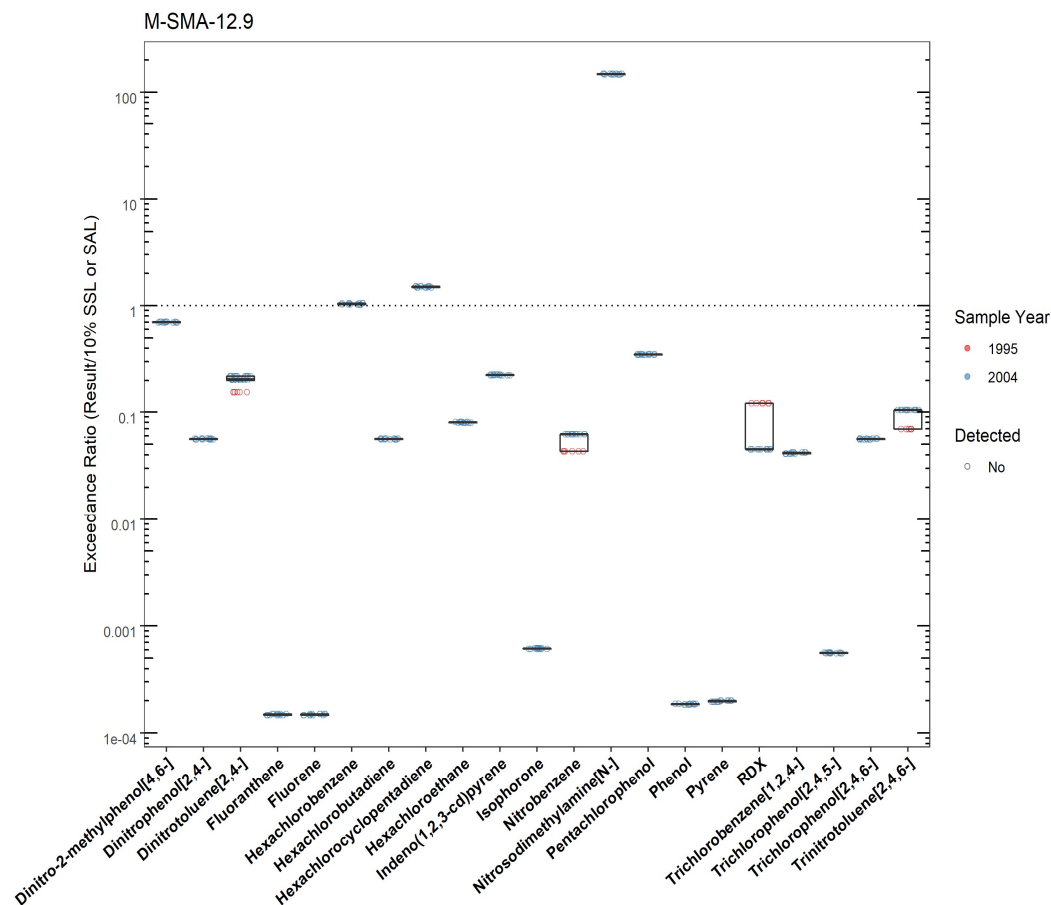
M-SMA-12.9 Soil Data (pt. 2)

SMA	Parameter Code	Detected	Screening Type	Screening Level (mg/kg)	Max Result (mg/kg)	Date of Max Result
Barium	M-SMA-12.9	Ba	Y	BTV	295	781	1995-06-20
Cadmium	M-SMA-12.9	Cd	Y	BTV	0.400	0.970	1995-06-20
Copper	M-SMA-12.9	Cu	Y	BTV	14.7	1500	1995-06-20
Lead	M-SMA-12.9	Pb	Y	BTV	22.3	1040	1995-06-20
Zinc	M-SMA-12.9	Zn	Y	BTV	48.8	141	1995-06-20

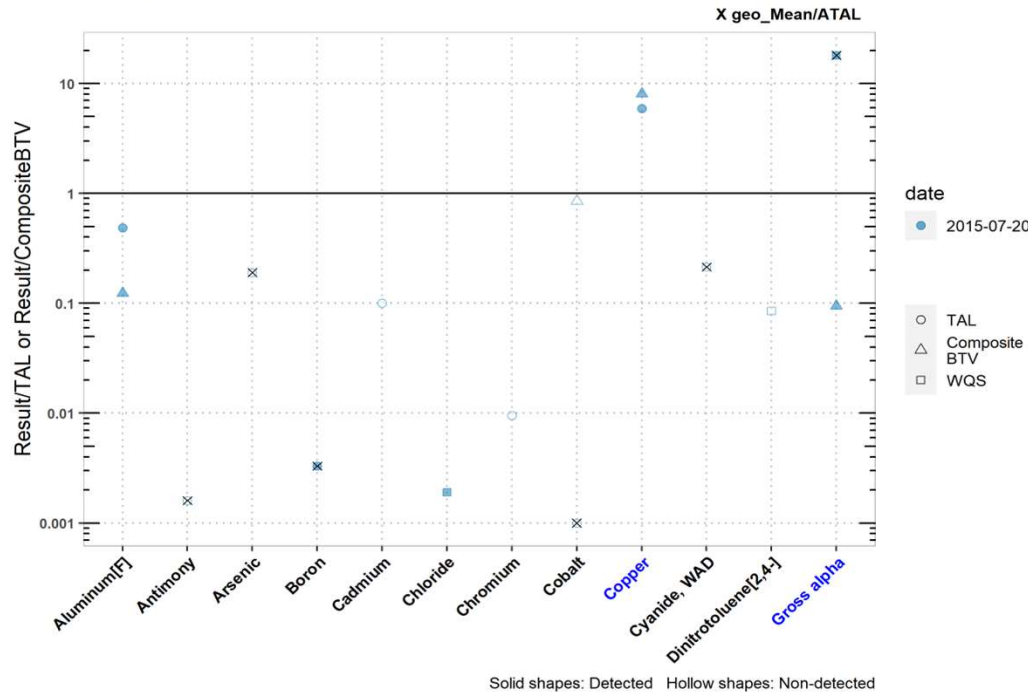
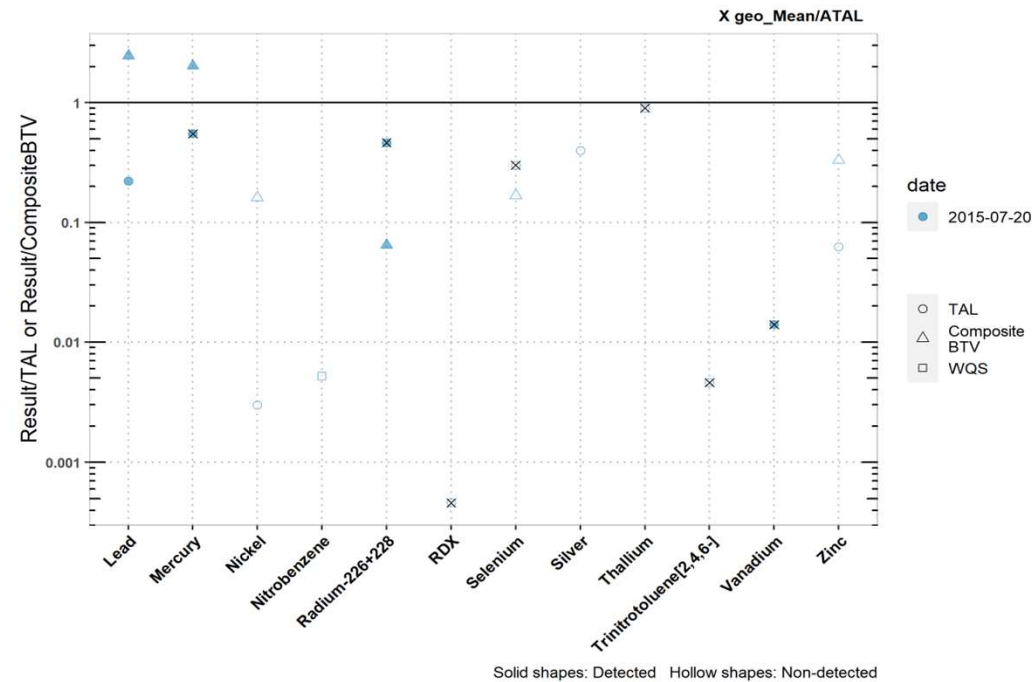
M-SMA-12.9 Stormwater Data

- Copper exceeded the TAL and BTV
- Gross alpha exceeded the TAL but not the BTV

- Due to receipt of COCs from NMED under the Consent Order this SMA was in Corrective Action Complete status under the 2010 Permit. However, that is no longer a compliance pathway under the 2022 Permit and the SMA was reevaluated.
- Barium exceeded the applicable screening value in soil data but is not a Site-related POC. Therefore, it will not be added for monitoring. Copper exceeded the applicable screening value in soil and exceeded the TAL in stormwater. The remaining metals that exceeded the applicable screening value in soil data were previously measured in stormwater data and did not exceed TALs.
- Gross alpha exceeded the TAL but not the BTV. **Copper exceeded the TAL and BTV, initiating corrective action.**
